Maryland Historical Trust Maryland Inventory of Historic Properties Form

Addendum to Inventory No. M: 26/8 Rose Hill Farm/Bullard Mansion Historic District

This Addendum adds the barn, milk house, and garden to the previously designated Rose Hill Farm/Bullard Mansion Historic District.

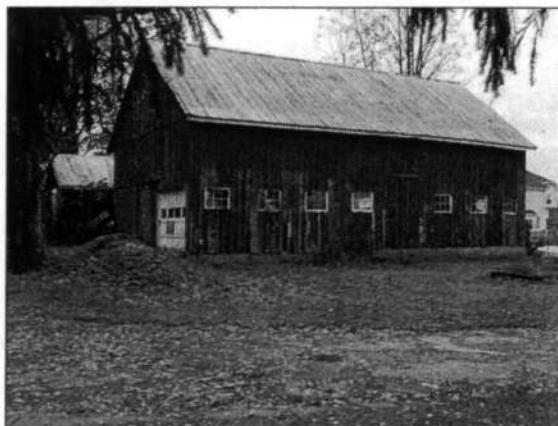
View of barn and milk house from northwest

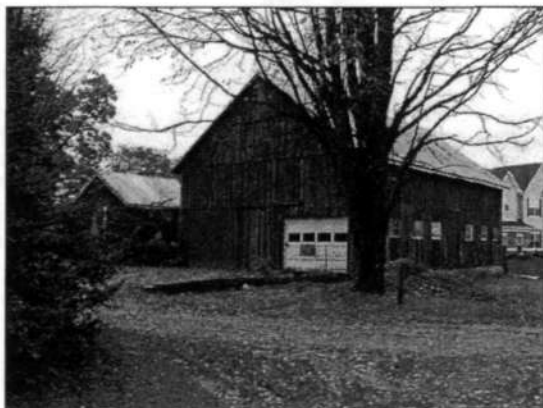
North (main) and west facades

The barn faces north and measures approximately 30 feet wide by 50 feet long. It is three bays wide, with two wide side aisles flanking a narrow center aisle, by four bays long. It is sheathed in vertical board and batten rough-sawn lumber and rests on a poured concrete foundation. The roof, which is covered with standing seam metal sheets, has no chimneys or vents, indicating that it is likely a replacement.

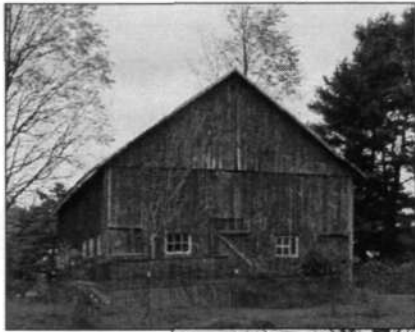
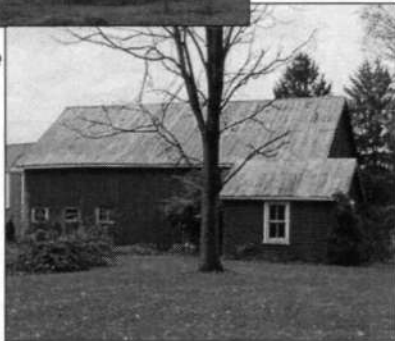
Fenestration in the barn consists of large and small door openings and a number of windows lining the long sides of the building. The windows are all six-pane fixed sashes, some of which are re-used from

**South façade
(top)**

**East façade
(bottom)**

six-over-six sash windows, possibly from the Rose Hill Mansion or a building on the grounds of the former Chestnut Lodge. The windows are arranged two per bay on each side, except in the second bay from the south, where doors rather than windows are present (main floor door on the east side, hayloft door on the west). The northernmost bay on the east side contains the passageway to the milk house.

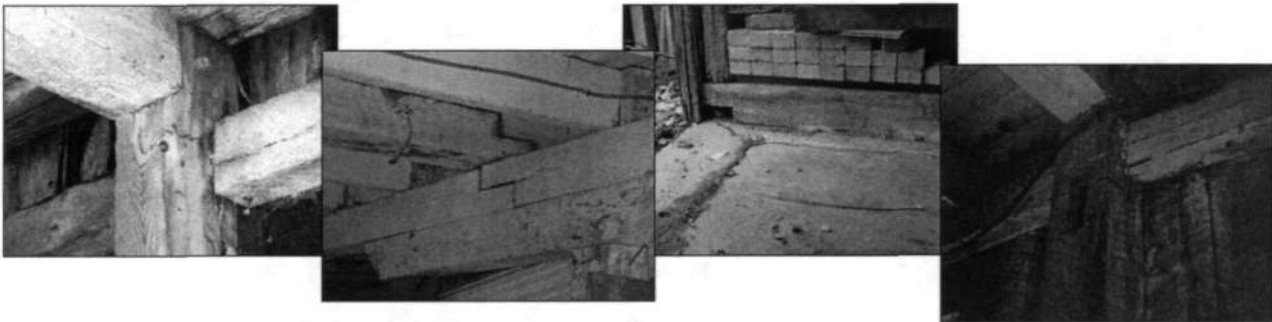
Inside, the structure of the barn is timber frame above the concrete foundation. The sills, posts, and beams are connected by a combination of half notch, nailed, and pegged and unpegged mortise and tenon joinery.

Various internal frame members showing joinery and reuse of timbers. Left to right: Pegged mortise and tenon joint on west wall, notch joints over interior door between aisles, sill plate (reused notched timber) at northeast corner, and a post along the west wall (with exposed mortise).

Many of the members have been reused from an older barn. The newer members tend to be smaller in dimension than the reused hewn timbers. The structure of the hayloft consists of a Queen post truss system, posts continuing from the first floor, corner braces, purlins, and rafters. Most of these members appear to be standard size machine cut lumber.

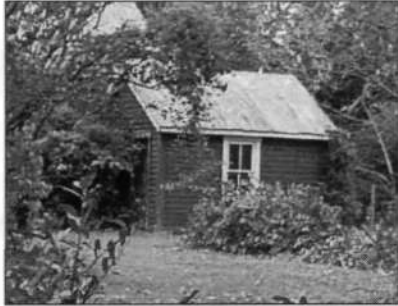
Associated with the barn is a small one-story milk house, which is connected to the barn through a narrow passageway to the east façade at the northeast corner. The passage has a gable roof with a historic paneled door leading into the milk house. The milk house is approximately 15 feet square with a poured concrete foundation. The building has horizontal, rough-sawn weatherboard siding and corrugated metal covering the front gable roof.

Milk house, southeast corner

From the exterior, the milk house is accessed through a six-panel wood door in its south façade. Windows in this small building are a six-over-six double hung sash window on the south façade, a one-over-one wood sash window in the north façade and a two-over-two wood sash window in the east façade. The door and windows are likely re-used elements from the main house. The interior of the milk house has a concrete floor, and concrete walls up to

approximately four feet. The upper walls and ceiling are white-washed, beaded tongue-and-groove boards flush on the walls. A concrete trough is located in the floor along the north wall.

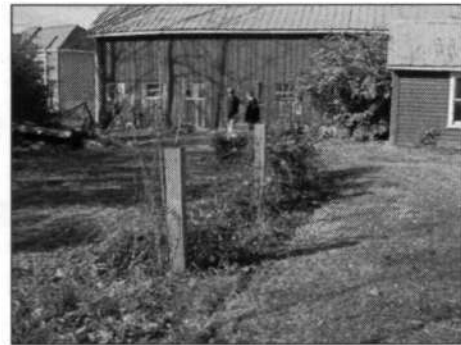
Between the Rose Hill Mansion and the agricultural outbuildings is a landscape rich with horticultural significance. The openness of this landscape reflects the formerly agrarian nature of Rose Hill. Planted here are several mature conifer and deciduous trees, the remnants of a fruit orchard, and grape vines believed to have descended from the earliest Catawba grape cuttings obtained from North Carolina.

Grape vines to east of barn

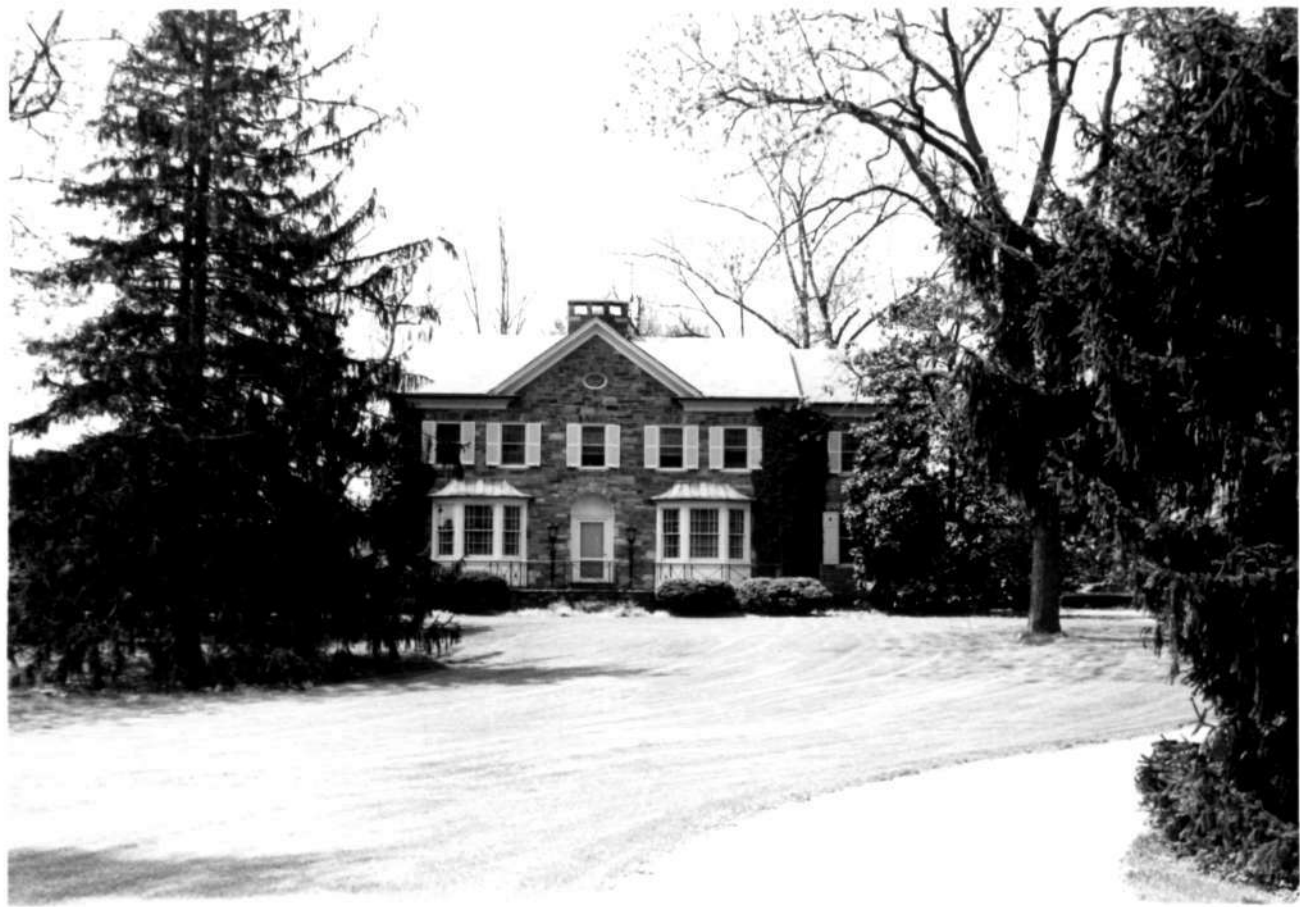
NAME ROSE HILL

Three facades of this frame house are veneered with stone. The south (front) facade has a center gable with a central oval window. The wooden paneled central door is topped by an arched panel. A metal topped oriel window is on either side of the door, and a large open slate-floored porch with iron railing runs the length of the main block.

FACADE E
